# **Coal Combustion Residual Landfill Annual Inspection Report Corrective Actions Resolution**

Boardman Generating Facility

Prepared by: Mathew Quigley, P.E.

*April 2018*

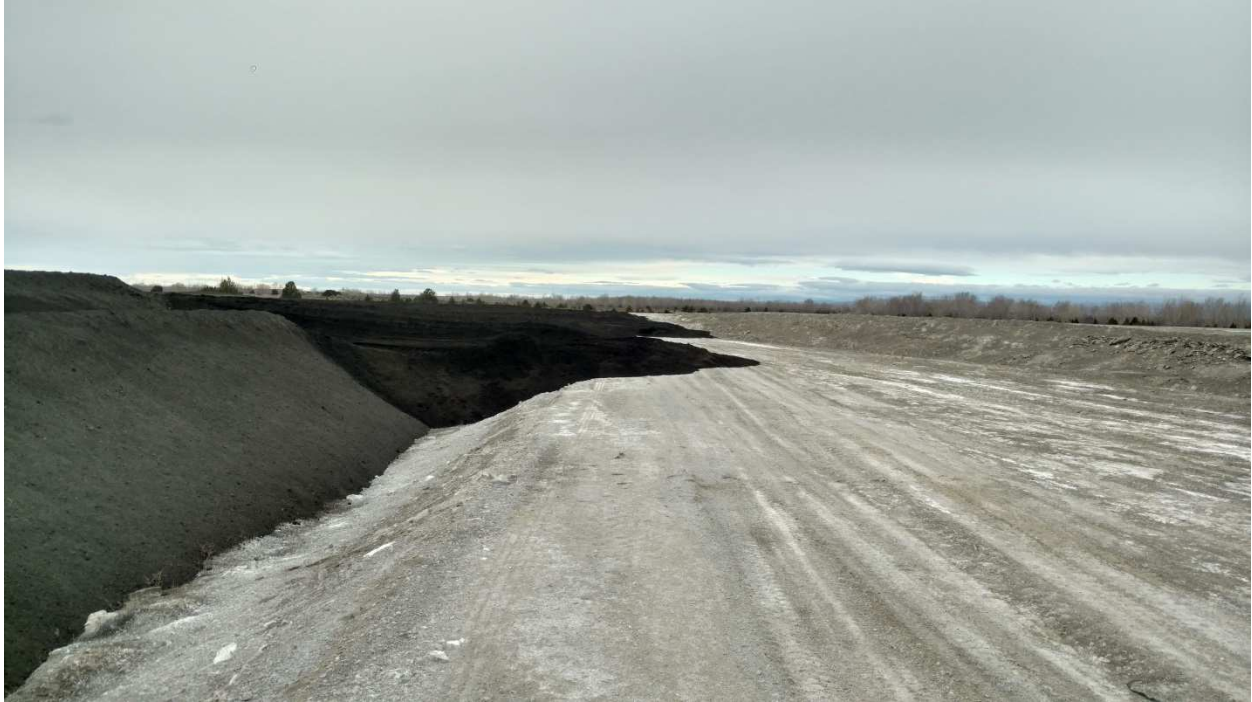
*Bottom ash being graded north over large ditch between bottom and fly/economizer ash piles.*

Work to fill in a ditch between the bottom and fly/economizer ash piles was undertaken on March 26<sup>th</sup> and completed on March 27<sup>th</sup>, 2018. Existing bottom ash materials were moved north toward the fly/economizer ash pile with a small dozer. The resulting slopes between the two piles now form a broad valley that can be filled and graded as more ash is deposited to form a uniform pile with slopes draining toward the site perimeter ditches. As this valley is filled, grading will be maintained to allow stormwater to drain east or west to reach site perimeter ditches and/or the stormwater retention area.

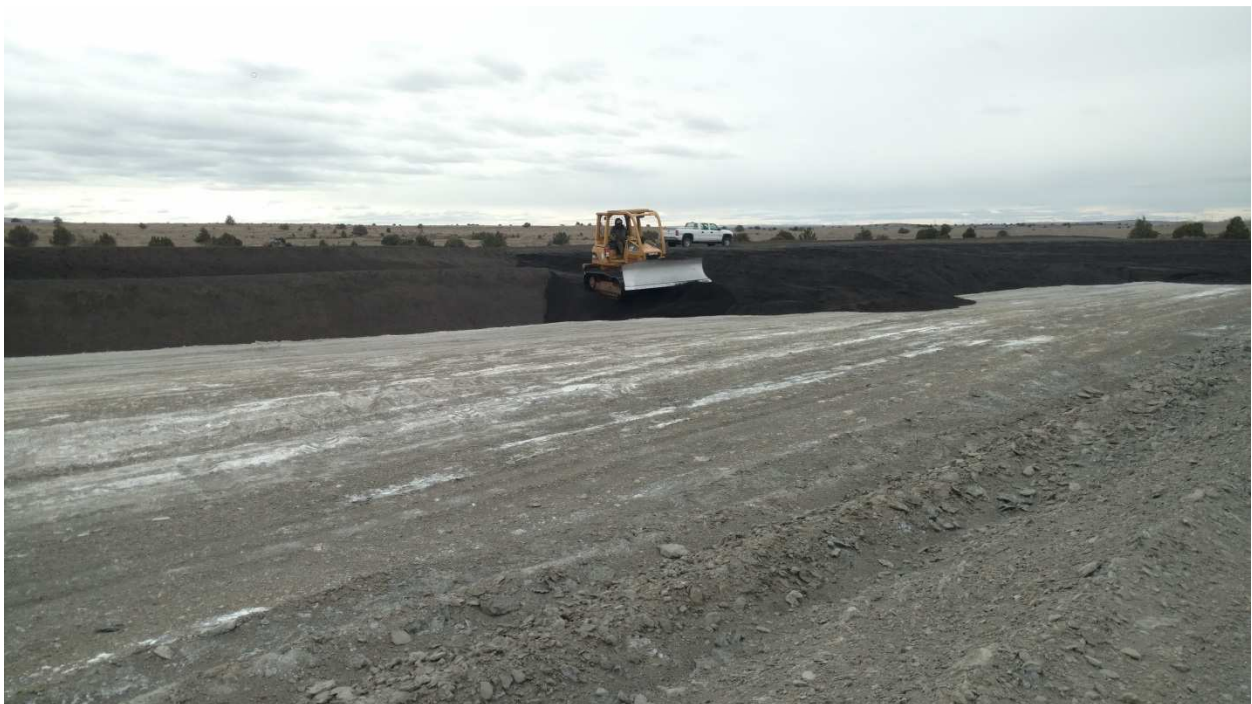
*Small dozer used for grading bottom ash toward fly/economizer ash.*

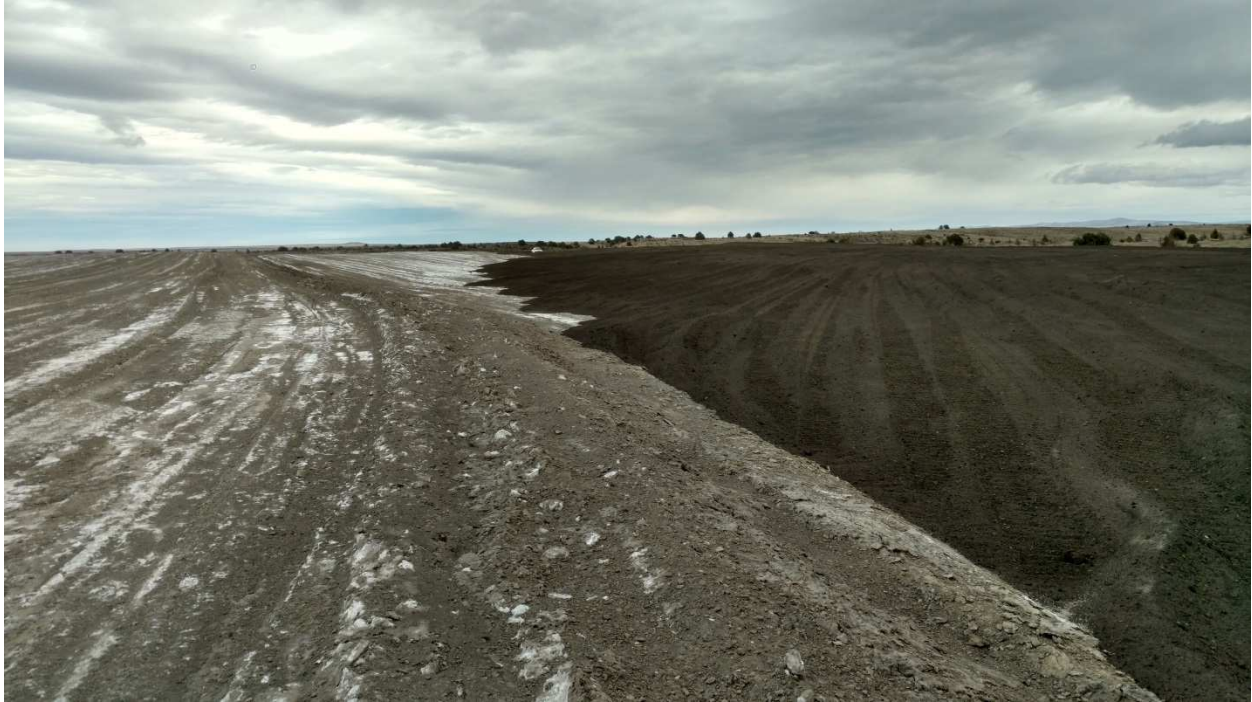
*Completed grading of bottom ash to form slopes to be graded and filled with new ash to form uniform pile.*

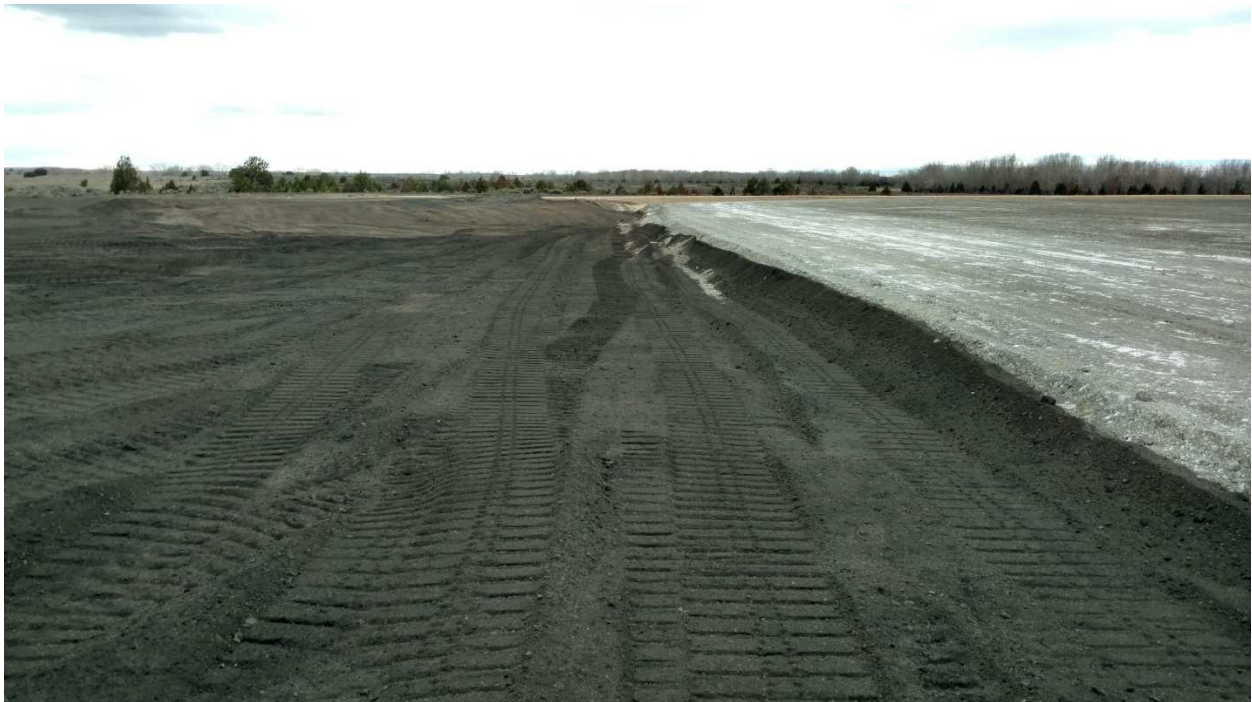
*Completed grading of bottom ash to form slope westward to stormwater retention area over previous ditch between bottom and fly/economizer ash*

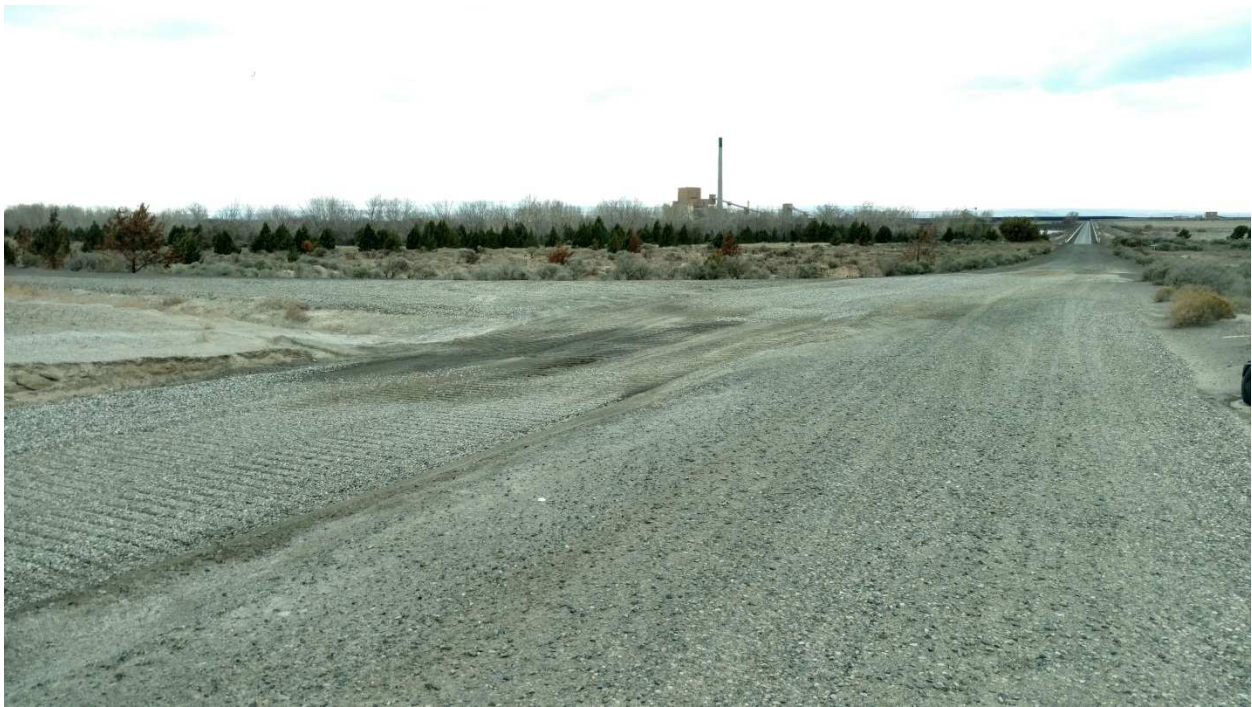
*New gravel placed upon northeast vehicle entrance. Note: ditch profile to be maintained as new gravel materials compact with use.*

Upon completion of grading activities described above, additional gravels were added to the northeast vehicle entrance as needed to reestablish the roadway and entrance slopes. Truck traffic is expected to compact new materials placed at the entrance. Therefore the entrance will continue to be monitored to insure the necessary ditch profile to convey stormwater runoff is maintained. Minor grading may be required throughout the year to maintain the profile.
